Technical Report 84049

GARTEUR/TP-007

**IMPACT DAMAGE TOLERANCE OF A
CARBON FIBRE COMPOSITE LAMINATE**

G. Dorey
P. Sigety
K. Stellbrink
W. G. J. Hart

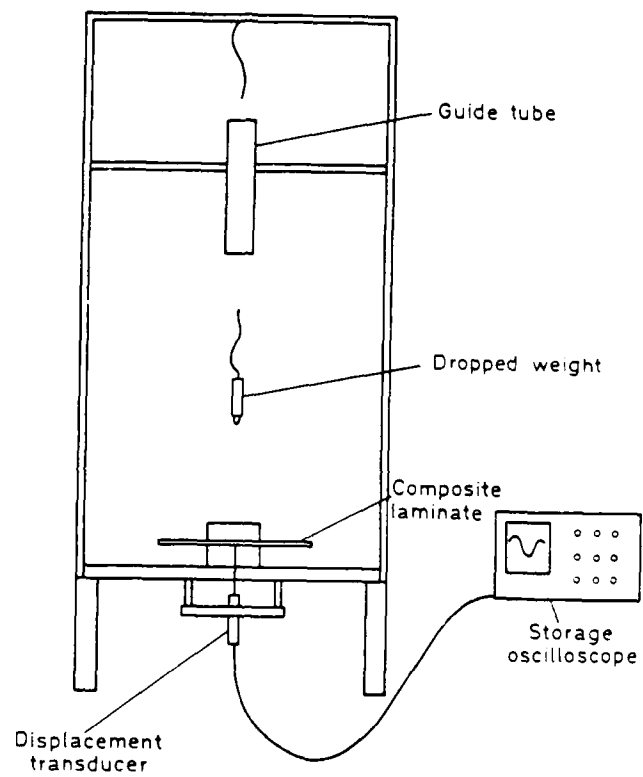
Fig 2 The ONERA apparatus for dropweight impact

A dropped weight is a simple, reproducible means of causing impact damage, typical of a dropped hand tool, but the type and extent of the damage depends on the test geometry⁴. The laminates were impacted before being cut into test specimens (250 mm \times 50 mm), except at NLR where, by mistake, specimens were cut out first. The laminates were supported horizontally over a steel cylindrical support, 100 mm internal diameter and 140 mm external diameter and clamped by means of a similar cylinder. The impactor was dropped through 1 m (impact velocity 4.43 m/s) and had a nose diameter of 10 mm. Typical arrangements are shown in Fig 2 (ONERA) and Fig 3 (DFVLR). RAE did some preliminary tests in which the mass of the dropped weight was varied. It was found that a mass of 306 gm (incident energy 3 J) caused damage that was barely visible, had little effect on tensile strength but caused a significant decrease in compressive strength (see section 4). Furthermore the lateral extent of the damage was less than 1/3 of the subsequent specimen width. Thus 3 J was chosen as the standard incident energy. The weight rebounded to a height of approximately 0.25 m, thus retaining 0.75 J energy and imparting 2.25 J to the specimen and its supports. Both ONERA and DFVLR instrumented their equipment. ONERA recorded the specimen oscillating at 55 Hz with a central displacement of about 4 mm. The DFVLR results are shown in Fig 4 showing the acceleration, velocity and displacement of the weight during impact, indicating a displacement of 4.5 mm, a maximum load of 1.58 kN and an absorbed energy of 1.63 J.

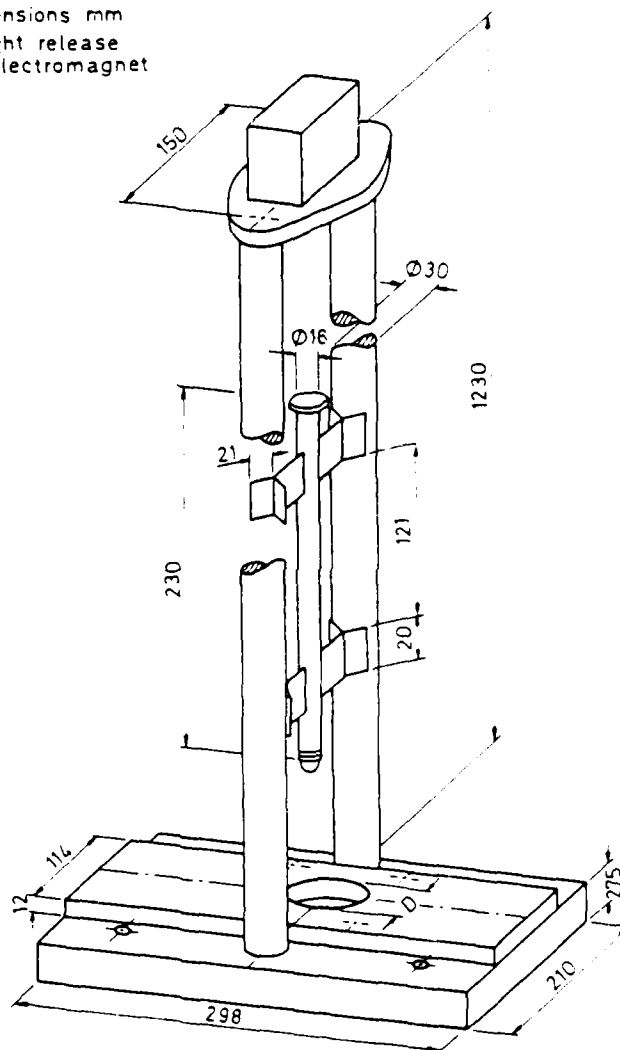
Dimensions mm
Weight release
by electromagnet

Fig 3 The DFVLR apparatus for dropweight impact

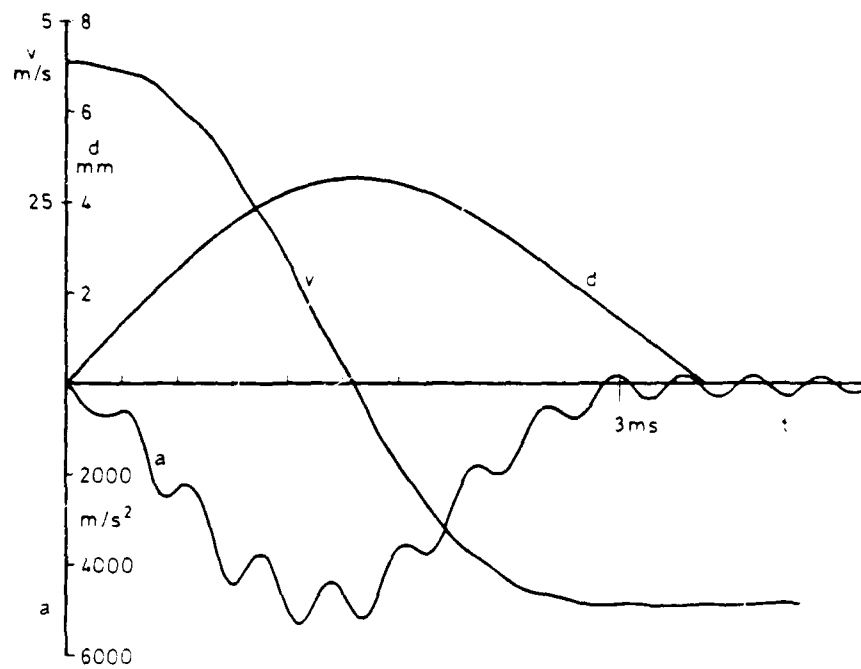
Dropped mass 300gm	Absorbed energy 1.63J
Drop height 1.0m	Displacement 4.5mm
Kinetic energy 3J	Maximum force 1.58kN

Fig 4 The displacement, velocity and acceleration of the dropped weight during impact (DFVLR)

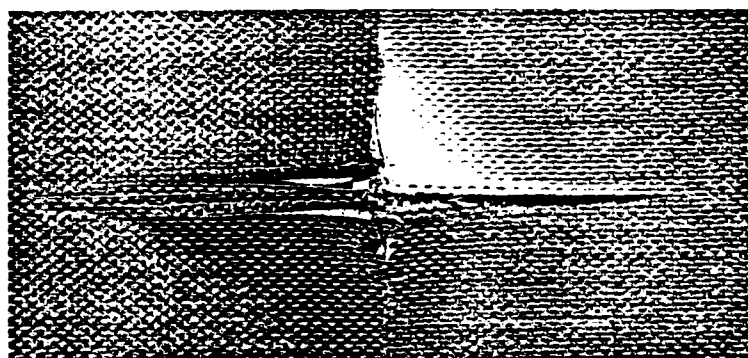
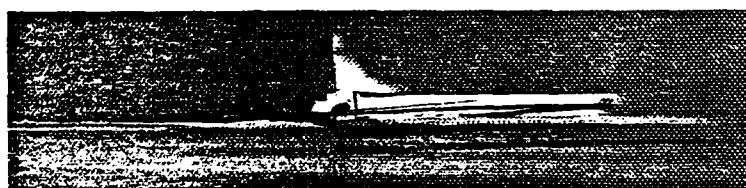
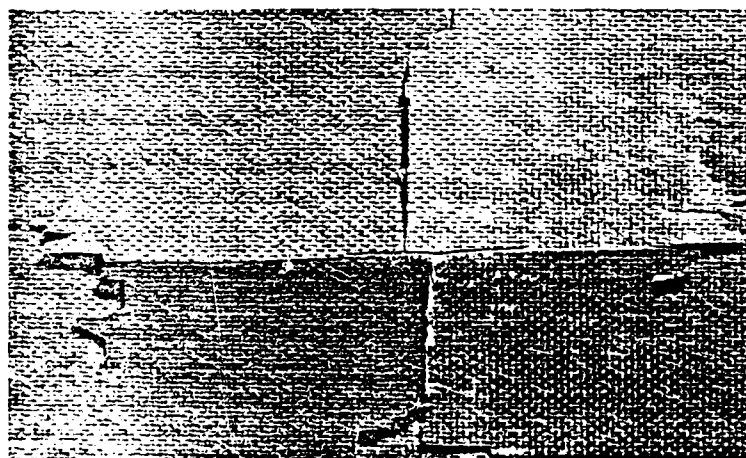
Fig 5a-c Backface damage on $[0\ 90\ 0\ -45\ 0]_s$ carbon fibre laminates from dropweight impact of 8 J energy (a) T300/914C (b) XAS/914C (c) a brittle CFRP (RAE)

For 3 J incident energy, the damage visible on the surface was a very slight dent on the front face and a split on the back face, 20 mm to 25 mm long, parallel to the fibres. Damage at a higher level of incident energy, 8 J, is shown in Fig 5 for both T300/914 and XAS/914. Both exhibit a tough fibrous fracture which is contrasted with the brittle behaviour of a similar $[0/90/0 \pm 45/0]_s$ laminate made over 10 years previously, with an excessive bond strength between the carbon fibre and the epoxy resin.

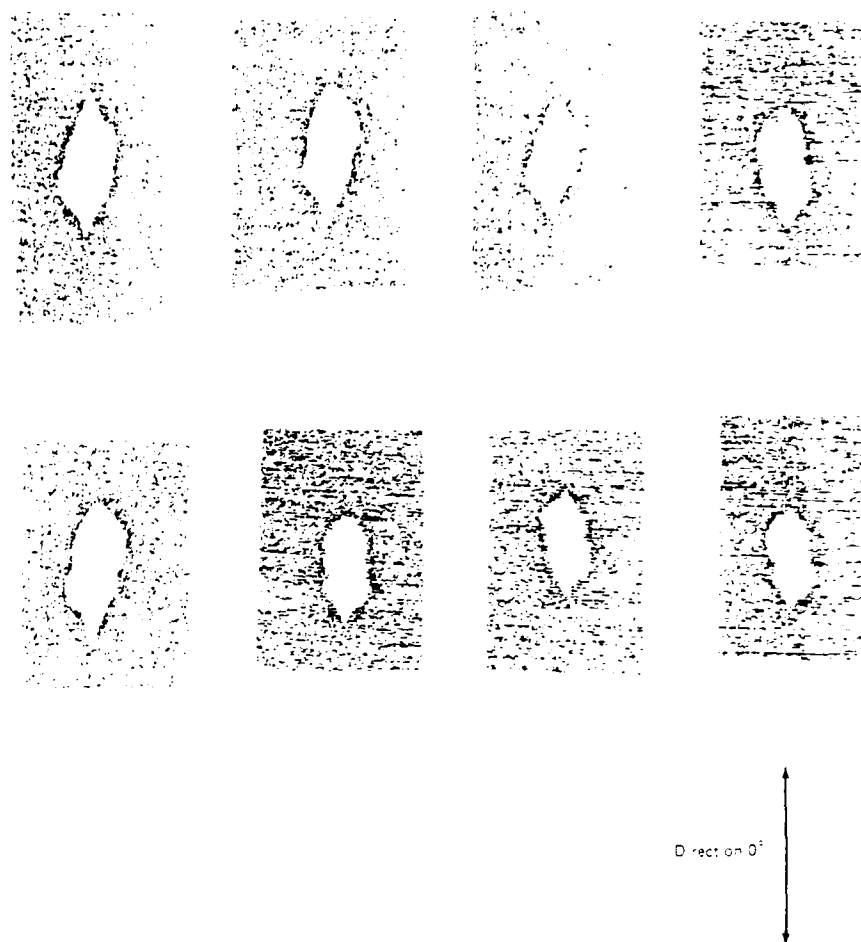
Fig 7 Areas of damage by ultrasonic C-scan for 3 J incident dropweight energy on a $[0/90/0/45/0]_5$ carbon fibre laminate (ONERA)

The panels were examined by ultrasonic C-scan in all four laboratories. Fig 6 shows the RAE results for various levels of incident energy, showing the areas of damage elongated in the direction of the 0° fibres. The reproducibility of the damage is shown in Fig 7 (ONERA) and Fig 8 (DFVLR) where delaminated areas were 212 mm² (CV 19%). Because the NLR specimens were more compliant under impact loading (thinner laminates and less rigid supports) more of the incident energy was taken in elastic deformation and

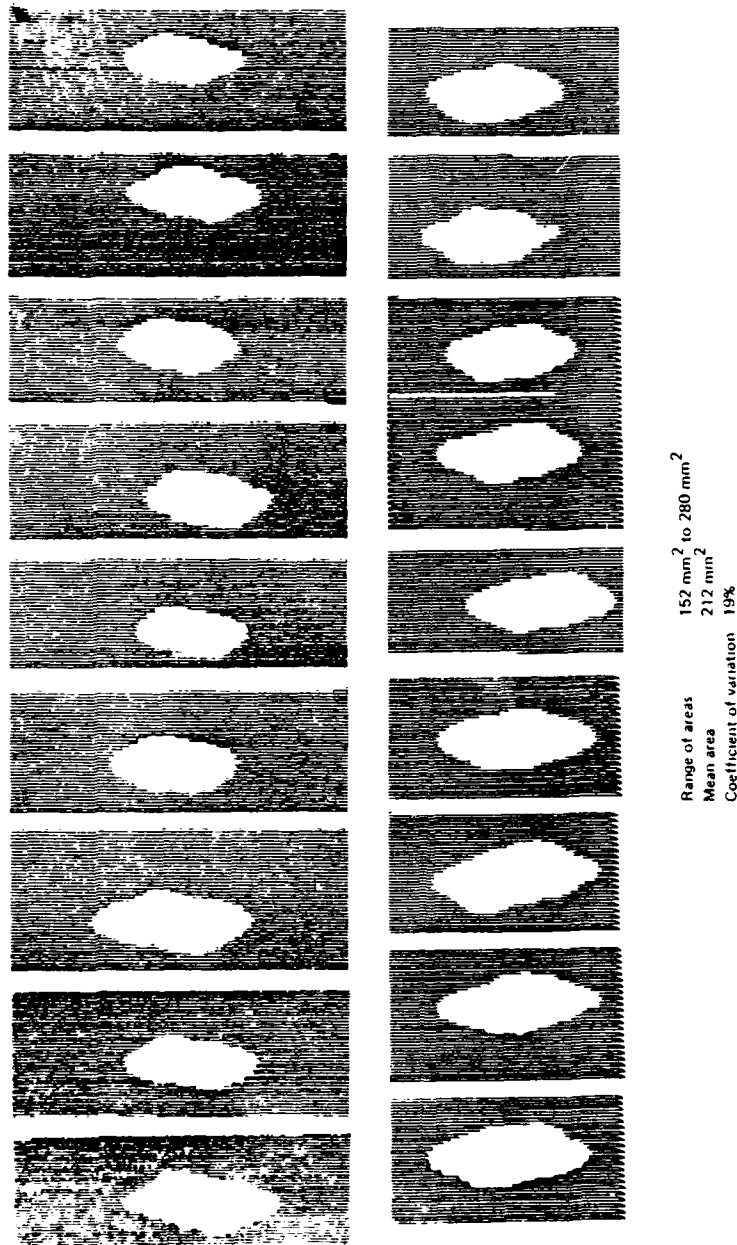
Fig 8 Areas of damage by ultrasonic C-scan for 3 J incident dropweight energy on a [0 90 0 +45 0] carbon fibre laminate (DFVLR)

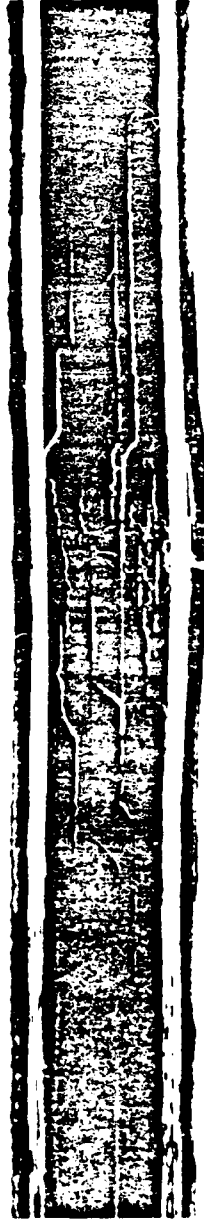
Fig 9 Cross section through the area of damage caused by 3 J incident dropweight energy on a [0 90 0 +45 0]_s carbon fibre laminate (DFVLH)

Cross sections were taken through the damaged areas and examined by optical microscope, Fig 9 (DFVLR) and Fig 10 (ONERA). These show multiple delaminations through the thickness the extent of the delaminations increasing towards the back face and extending further in the 0° direction. In Fig 10a it can be seen that the delaminations occurred at the ±45 interface and on the impact side of all the 0° plies. Since the impact supports were circular all the plies were radial through the damage area. The asymmetry arose therefore because of the greater stiffness in the 0° direction, due to the greater number of 0° plies and the 0° plies on the outside, thus causing greater stresses in this direction. The extent of delamination associated with individual interfaces can be seen more clearly in translucent materials such as glass fibre or aramid fibre laminates⁵, in which the delamination extended on the impact side of each ply in the direction of the stiff fibres in that ply. Also in Figs 9 and 10 can be seen transverse cracks in each ply angled at approximately 45° to the laminate plane so as to be perpendicular to the tensile component of the shear stress associated with the flexure.

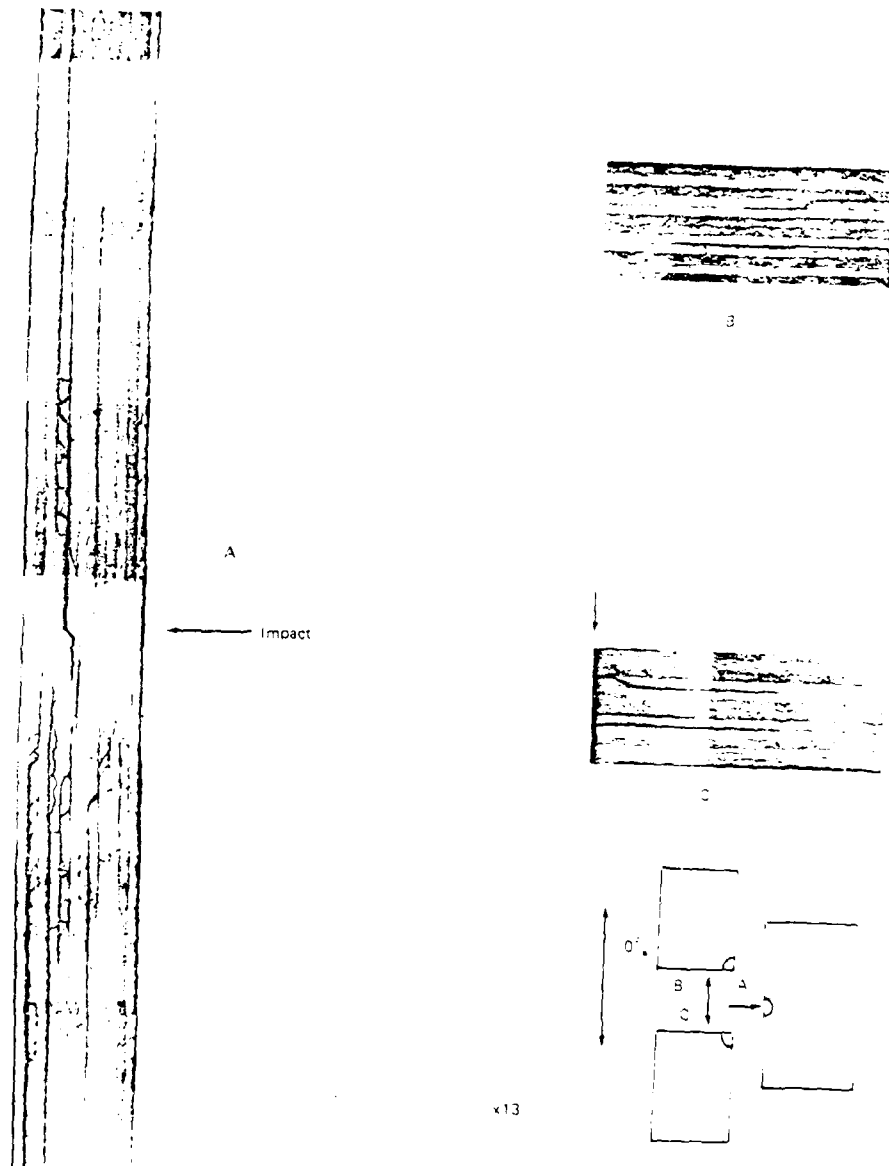
Fig 10 Cross sections through the area of damage caused by 3 J incident dropweight energy on a $[0\ 90\ 0\ -45\ 0]_s$ carbon fibre laminate (ONERA)

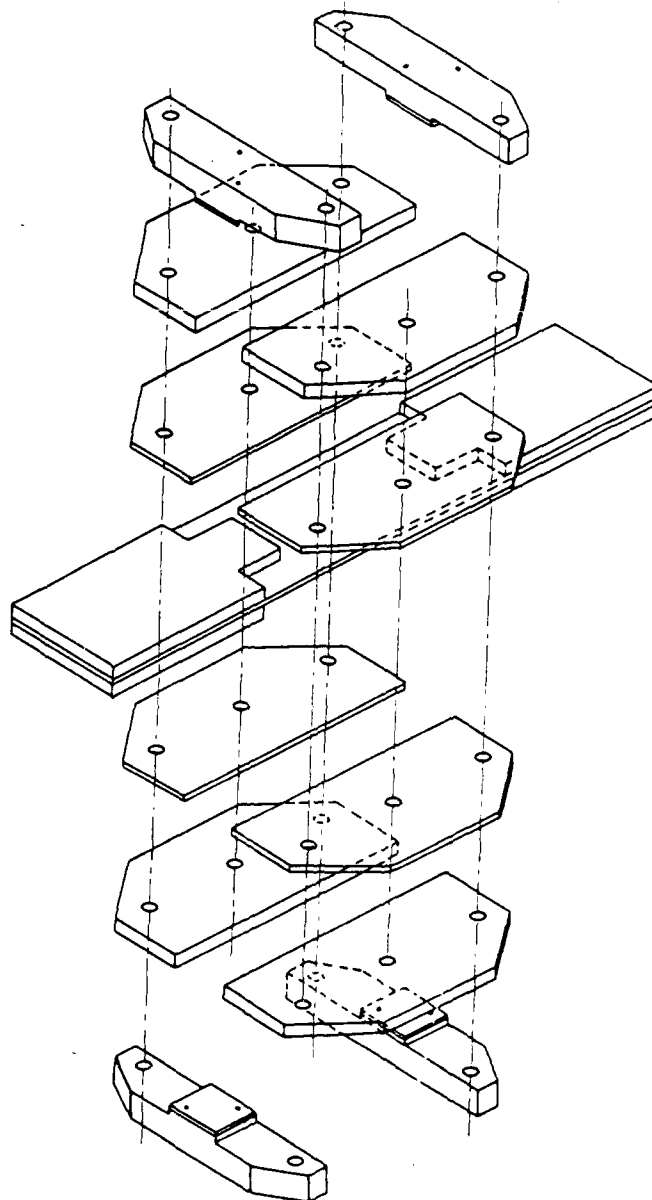
Fig 11 Exploded view of DFVLR anti-buckling device

After impact and inspection the panels were cut into specimens 250 mm × 50 mm, so that the damage was at the centre, and tested in either axial tension or axial compression. In compression an anti-buckling device was used to prevent gross buckling of the specimen but to allow local buckling of damaged plies. All four laboratories used similar anti-buckling devices based on a design by DFVLR and shown in Figs 11 to 14. The side plates, coated with PTFE to reduce friction, provided edge restraint approximately 12 mm in from each side over most of the gauge length, leaving a gap of only a few mm to allow for compressive strain. The T-pieces were used so that the small gap did not extend in a straight line across the specimen. These T-pieces had roughened surfaces (except on the tongue of the T) so that they could be clamped on to the specimen in the test machine's grips, without having to use adhesive. It was found that the T-pieces had to be restrained by the cross members (see Figs 11 and 13) to prevent out-of-plane movement. Thus the unrestrained portion of the gauge length was 70 mm × 26 mm with the damaged area approximately 25 mm × 10 mm at the centre. NLR tested some undamaged specimens in compression with gauges on each side (see Fig 14) and found that the unrestrained portion buckled for applied loads greater than about 33 kN corresponding to a strain of 0.55%. For the thicker specimens used by the other three laboratories this would occur at about 0.79% strain or 530 MPa applied stress. Fig 15 shows some results for damaged specimens tested in tension; the load strain curves were almost identical for the two strain gauge locations, confirming that the delamination damage had had negligible effect on the local in-plane tensile stiffness.

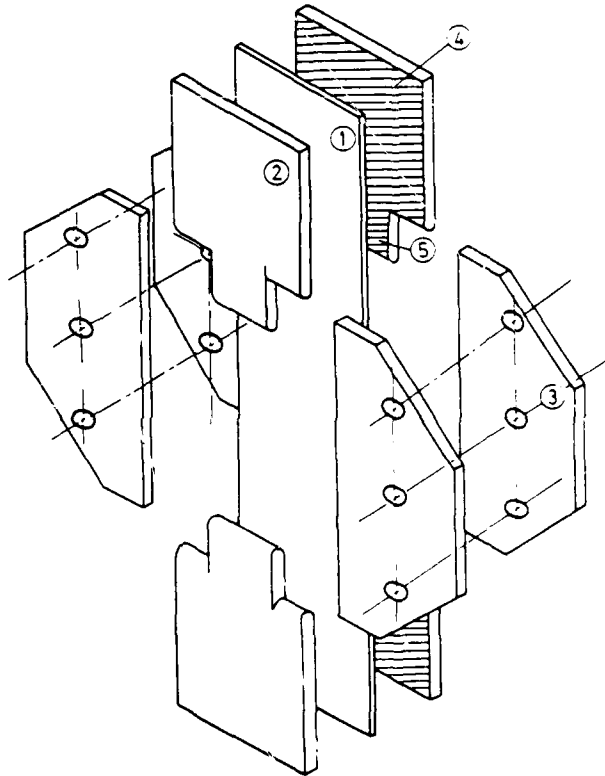
- ① Specimen
- ② End plate
- ③ Anti-buckling guide
- ④ Emery paper
- ⑤ PTFE film

Fig 12 Exploded view of ONERA anti-buckling device

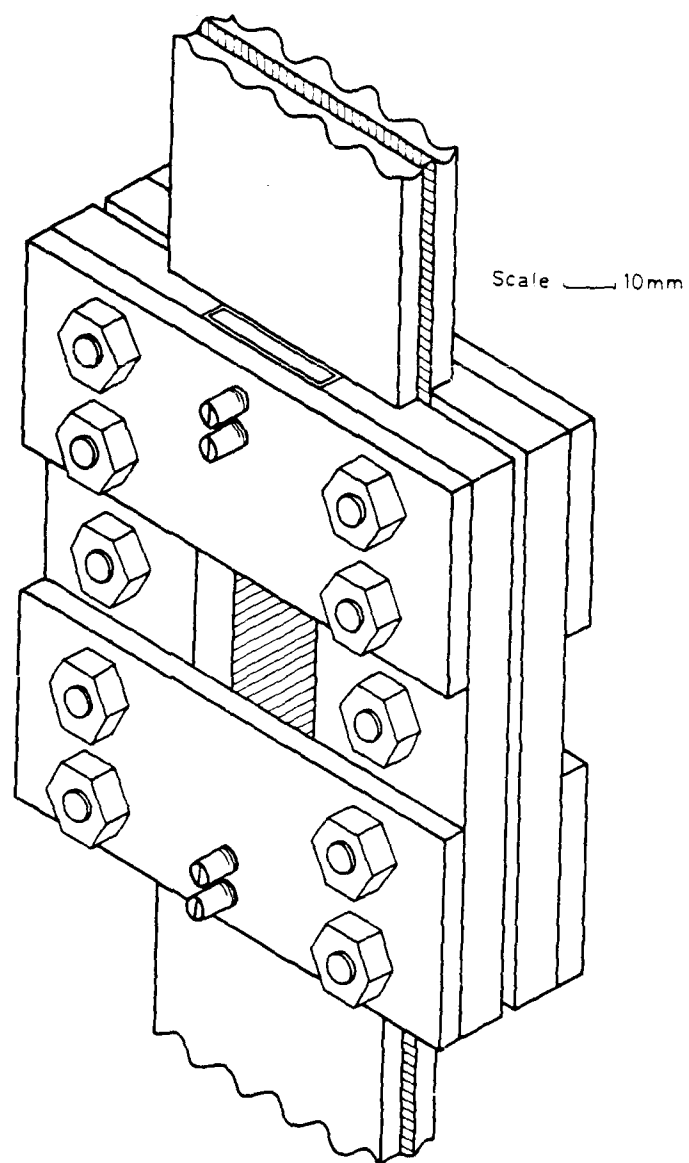
Fig 13 Assembled view of RAE anti-buckling device

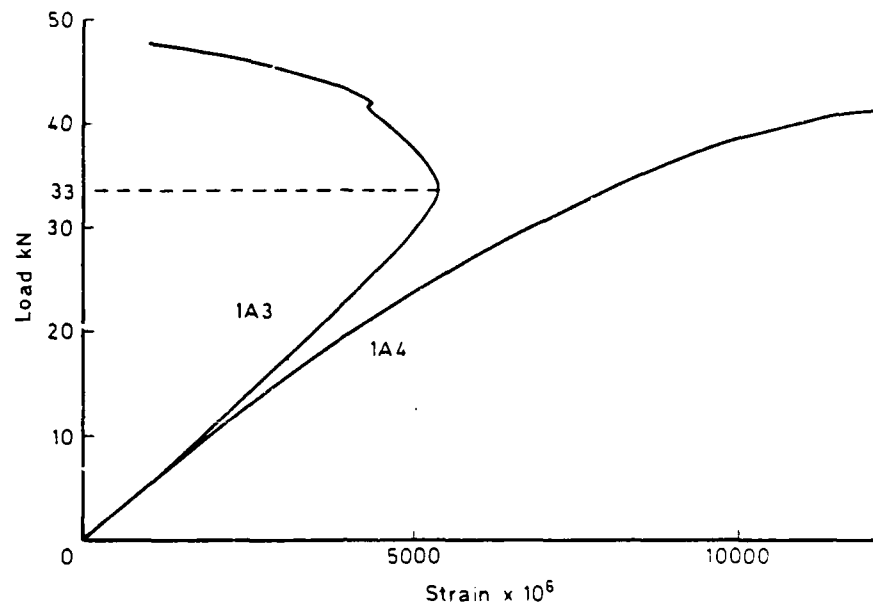
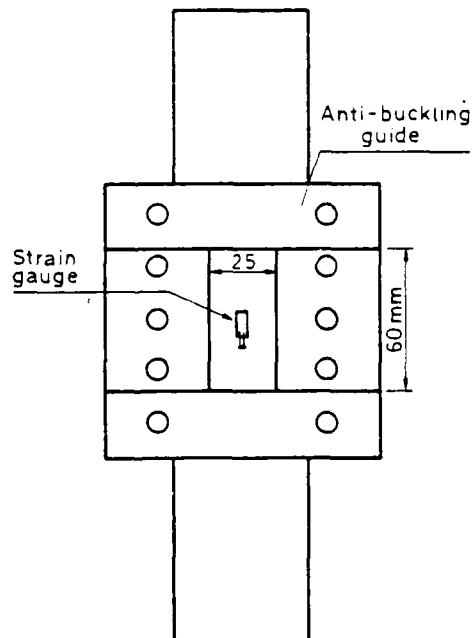
Fig 14 NLR anti-buckling device and load-strain curves of specimens tested in compression

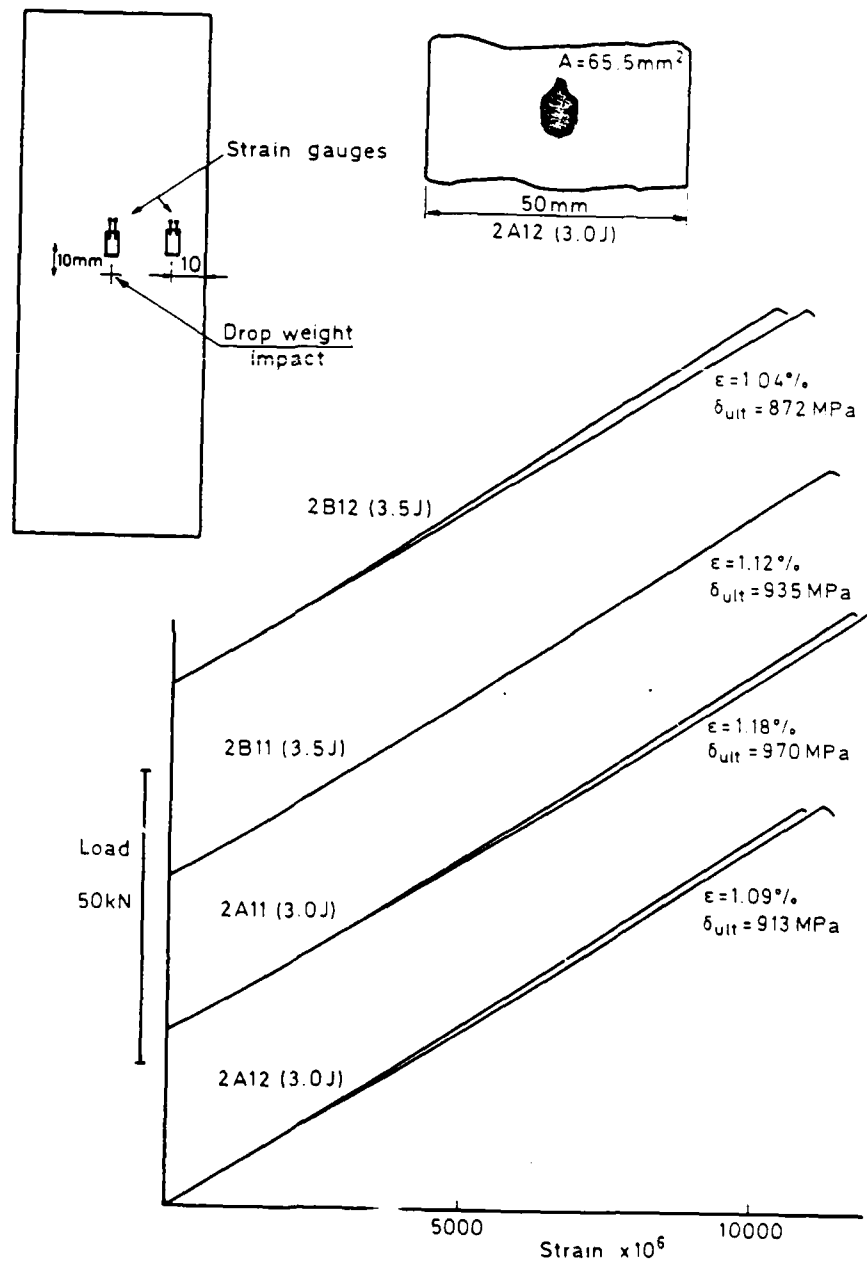
Fig 15 Load-strain curves of impact damaged specimens tested in tension and a typical C-scan of the damage (NLR)

The NLR specimens that had not failed in fatigue were inspected by ultrasonic C-scan and the scans are shown in Fig 25. Comparing these results with that shown in Fig 15 it can be seen that, with the exception of specimen 2A3, there is very little evidence of major delamination, even though specimens 2A6, 2A9 and 2A10 had indicated a reduction in stiffness: there was however a small amount of damage growth in the 0° direction.

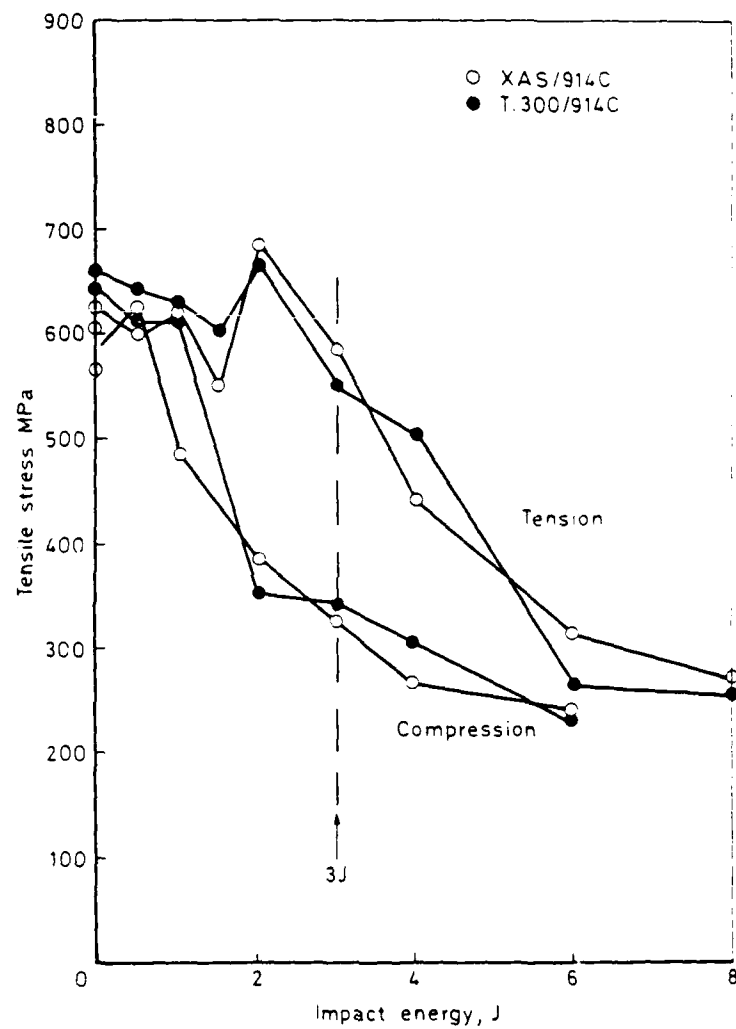
Fig 16 Effect of dropweight impact on the residual tensile and compressive strengths of $[0\ 90\ 0\ -45\ 0]_s$ carbon fibre laminates (RAE)

RAE had damaged some of the laminates over a range of incident dropweight energies and the residual tension and compression strengths are shown in Fig 16. The results for XAS 1914 and T300/914 were very similar. The tensile strength was not affected much by

the delamination damage that occurred up to 3 J incident energy, but the fibre damage at 4 J and above caused significant reductions in strength. The delamination however did not reduce the compressive strength for incident energies greater than 1 J. From these results it was decided that the standard damage for the subsequent fatigue tests would be that caused by 3 J incident energy. Tables 2 to 4 give the results of the static tests. There was reasonable agreement for the compressive strength: 590 \pm 50 MPa for undamaged specimens and 340 \pm 40 MPa for damaged specimens. For the tensile strengths there were much greater differences between the laboratories for both damaged and undamaged specimens: 630 MPa to 930 MPa for undamaged specimens and 490 MPa to 960 MPa for damaged specimens. It is assumed that these differences in tensile strengths found by the laboratories was caused by differences in stress concentrations associated with gripping the test specimens, and this is supported by photographs of broken specimens shown in section b.

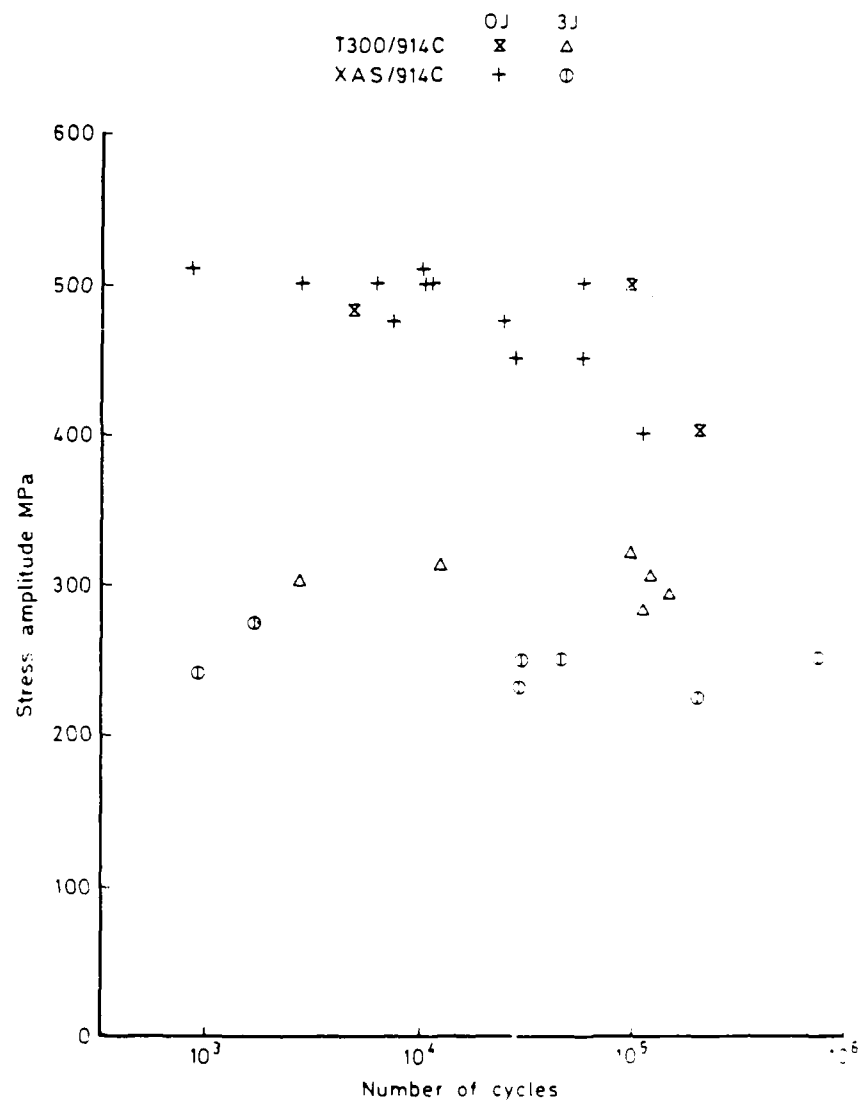
Fig 17 Fatigue curves ($R = -1$) for undamaged and impact damaged $[0\ 90\ 0\ \pm 45\ 0]_s$ carbon fibre laminates (RAE)

The results are given in Tables 5 to 7 and plotted in Figs 17 to 20. The results for all four laboratories are plotted together in Fig 21. It can be seen that there is much better agreement for the fatigue results than for the static results. The values for undamaged specimens fall from about 600 MPa at short lives to about 300 MPa at 10^7 cycles. The slope of the curve for damaged specimens shows less degradation, from just over 300 MPa at short lives to over 200 MPa at 10^6 cycles.

The RAE results shown in Fig 17 indicate that for the undamaged specimens there was very little difference between XAS/914 and T300/914. For damaged specimens, the slightly greater area of delamination in XAS/914 (see Fig 6) led to slightly lower fatigue strengths, but for both materials there was no evidence of any further reduction in fatigue strength up to 10^6 cycles. The NLR results (Fig 18) showed no significant difference between the specimens impacted by 3 J and those impacted by 3.5 J. The ONERA results (Fig 19) show, for undamaged specimens, that specimens failing in the gauge length and those failing near the ends had similar fatigue lives. The DFVLR results (Fig 20) show the importance of the restraints on the T-pieces to avoid out-of-plane movement; the open circles for unrestrained ends all showed lower fatigue lives than the filled circles for specimens with restrained ends.

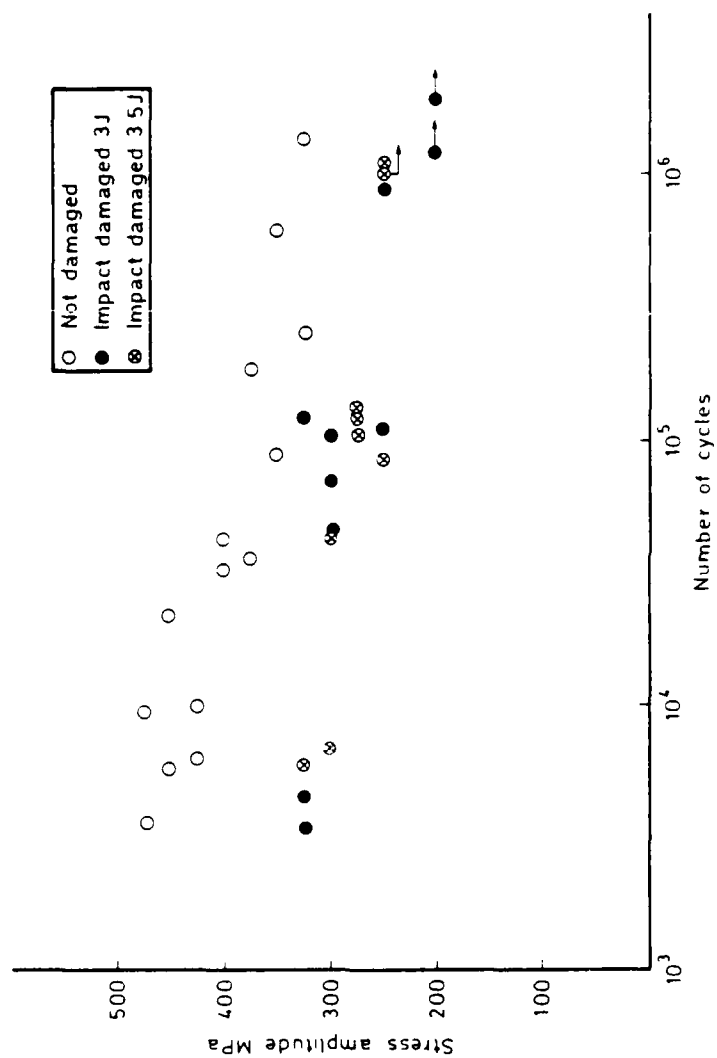
Fig 18 Fatigue curves ($R = 1$) for undamaged and impact damaged $[0/90/0/45/0]_s$ carbon fibre laminates (NLR)

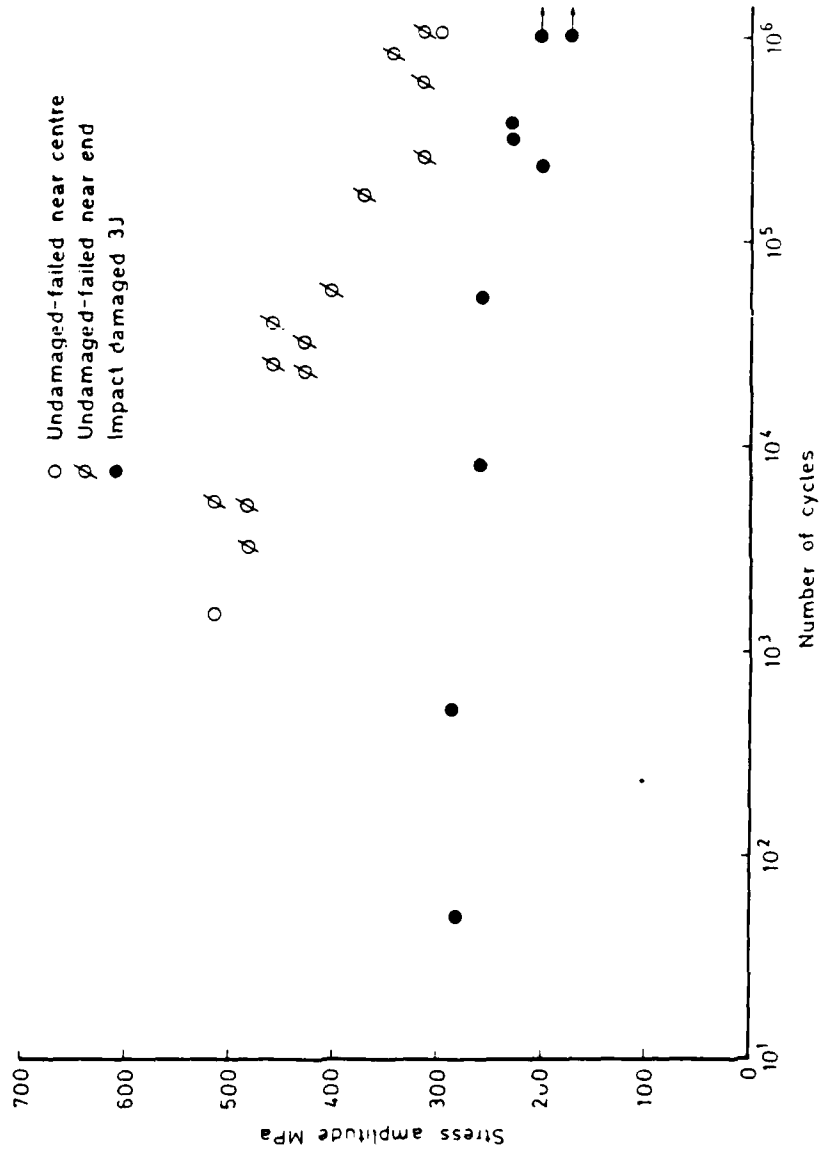
Fig 19 Fatigue curves ($R = 1$) for undamaged and impact damaged $[0/90/0/45/0]_s$ carbon fibre laminates (ONERA)

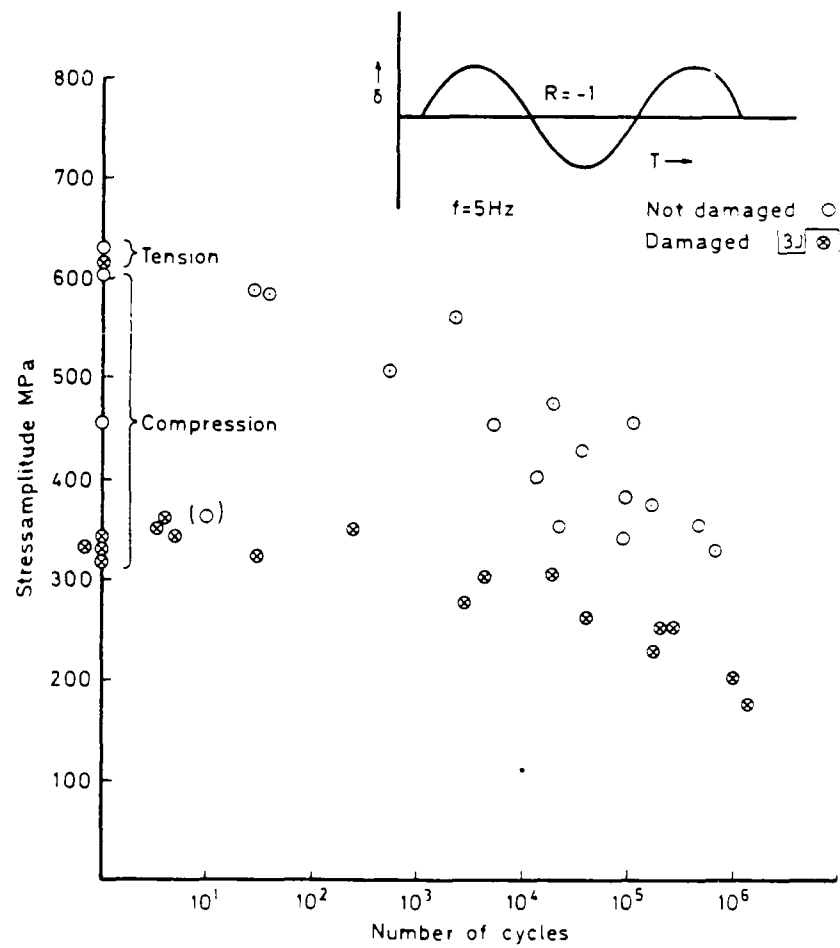
○ T pieces restrained from out-of-plane movement

Fig 20 Fatigue curves ($R = -1$) for undamaged and impact damaged $[0\ 90\ 0\ 45\ 0]_s$ carbon fibre laminates (DFVLR)

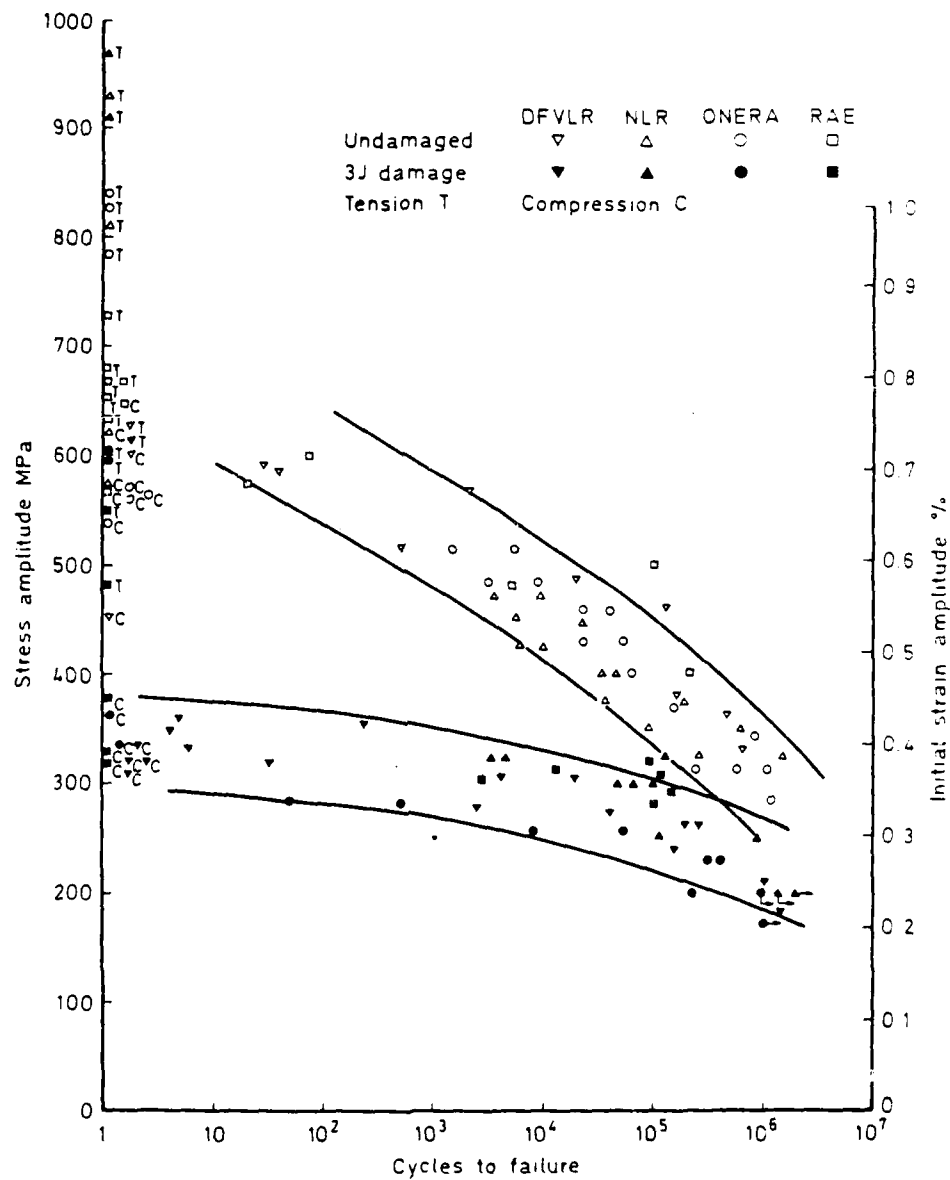
Fig 21 Combined fatigue results ($R = -1$) from the four laboratories for undamaged and impact damaged $[0\ 90\ 0\ \pm 45\ 0]_s$ carbon fibre laminates

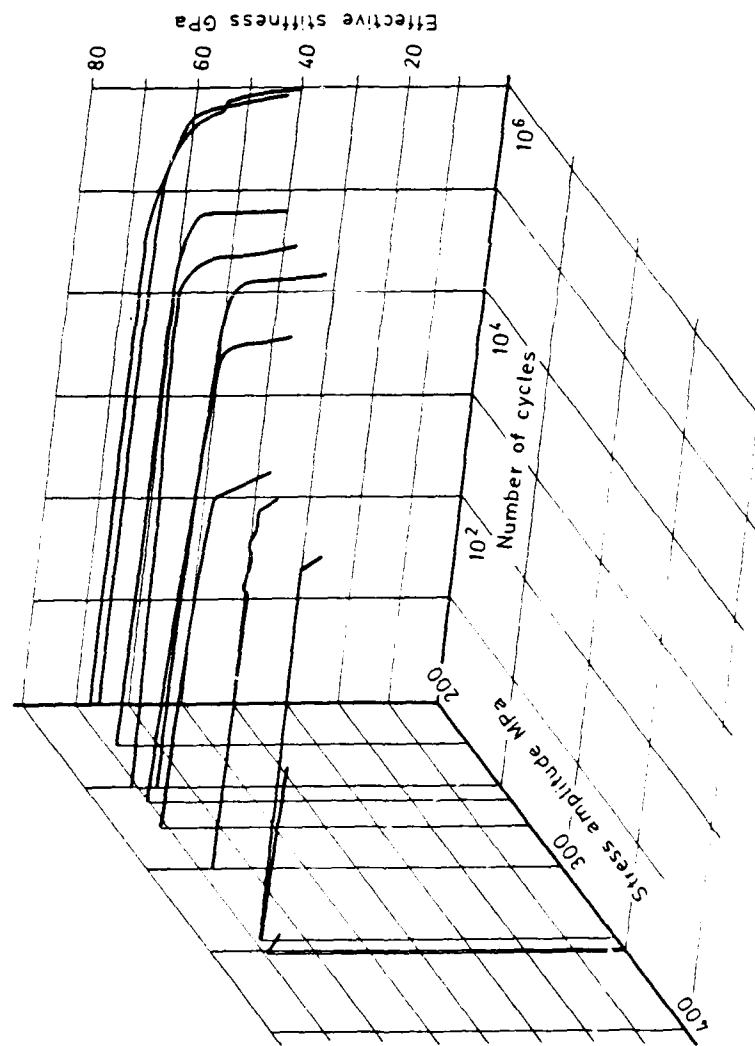
Fig 22 Loss in stiffness during fully reversed fatigue loading of impact damaged (3J) [0.90.0 + 45.0]_s carbon fibre laminates (DFVLR)

DFVLR monitored the stiffness of the specimen electro-optically by recording the root mean square elongation of a 50 mm section of gauge length. With undamaged specimens no change in stiffness was detected, but with damaged specimens the stiffness reduced towards the end of the fatigue life as shown in Fig 22. This was mainly due to an increase in compressive compliance. If these results were plotted on a linear scale, the reduction in stiffness would commence at about half the eventual lifetime. This reduction in stiffness towards the end of the fatigue life of damaged specimens was sufficient to stop the test on the NLR machine. These specimens were then tested statically in tension; although there had been damage growth leading to a reduction in compressive stiffness, there was no apparent reduction in residual tensile strength.

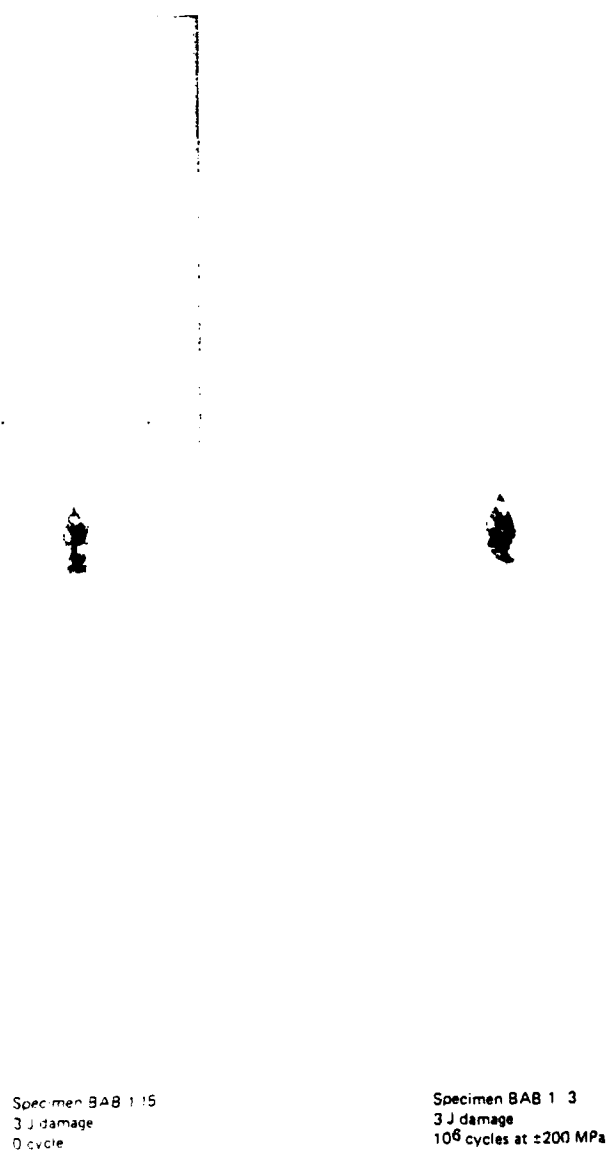
Fig 23 Examination of damaged laminates using X-rays and radio-opaque dye (ONERA)

ONERA monitored the damage using X-rays and a radio-opaque dye. Fig 23 shows the damage for two specimens, one immediately after impact and the other after 10^6 cycles. There is no apparent evidence of any damage growth, apart perhaps from some small tracks in the 0° direction. There was no evidence of any edge cracking, which has been observed with other stacking sequences⁶. Calculations at ONERA, of the edge stresses expected from the present stacking sequence, are shown in Fig 24. The maximum stress was for σ_{zz} , the through-thickness normal stress, but this was only about 5% of the applied stress and would not be expected to cause cracking.

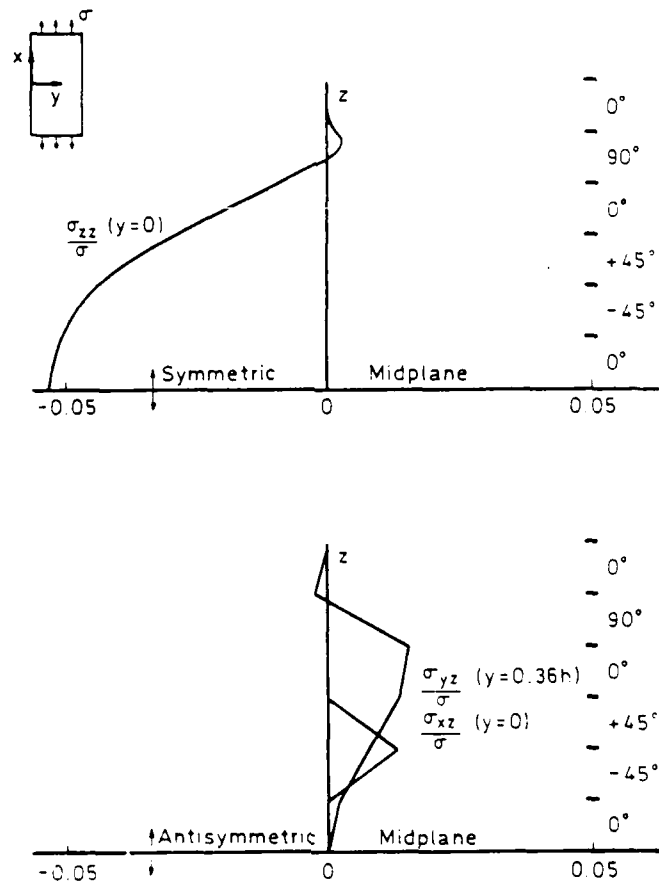
Fig 24 Calculated stresses at the edge of a $[0\ 90\ 0\ \pm 45\ 0]_s$ carbon fibre laminate (ONERA)

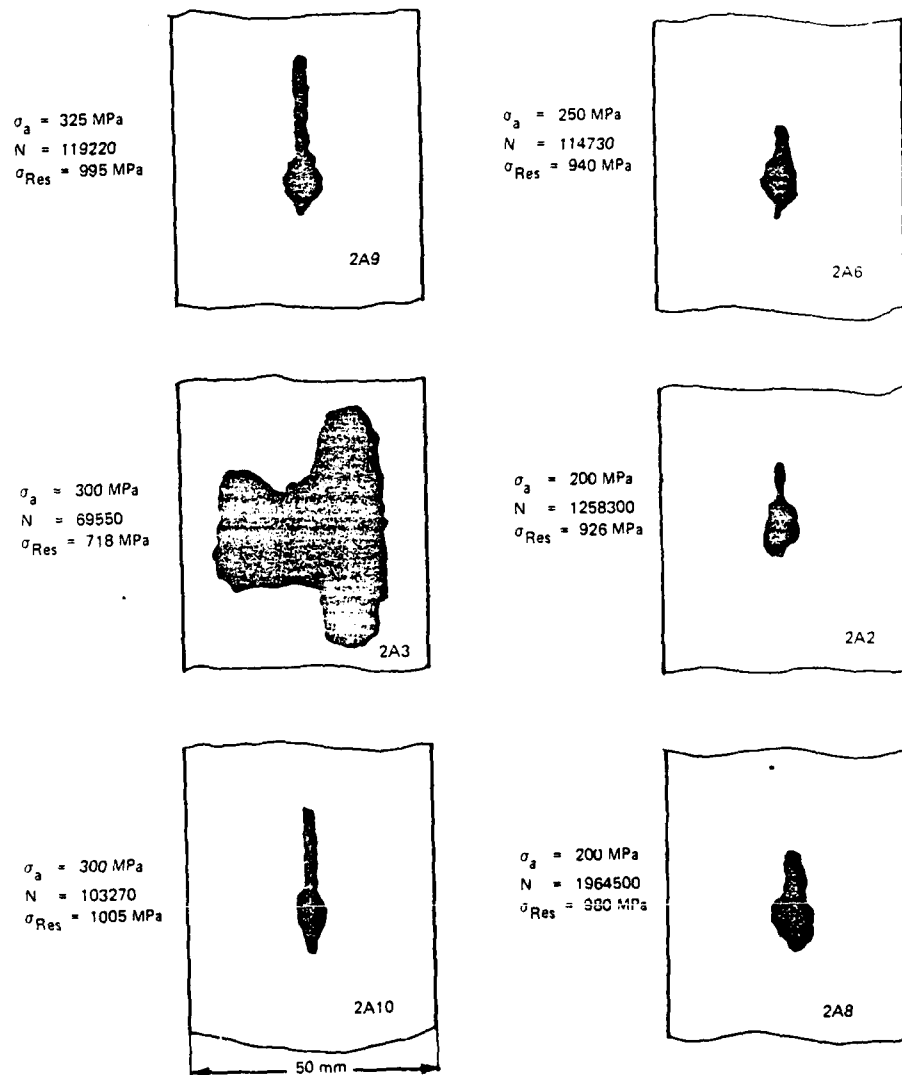
Fig 25 Ultrasonic C-scans of damage after fatigue loading showing limited damage growth (NLR)

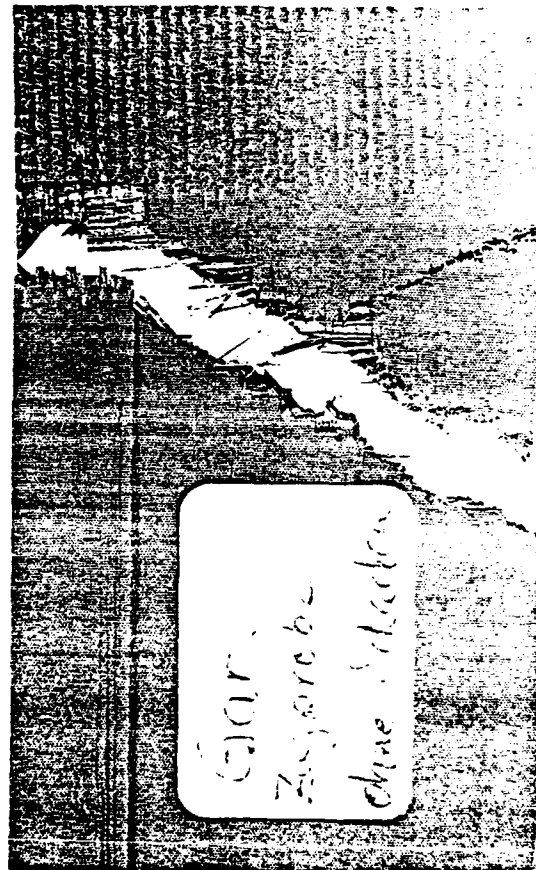
Fig 26 Static tensile failure in a $[0\ 90\ 0\ \pm 45\ 0]_s$ carbon fibre laminate (DFVLR)

Photographs of fractured specimens are shown in Figs 26 to 31. The static tension specimen shown in Fig 26 (DFVLR) shows evidence of failure from a stress concentration at the end grip; this might explain why DFVLR did not get any static tensile strengths above 630 MPa. Fig 27 shows static tensile specimens for XAS/914 and T300/914; as in the case of C-scans (Fig 6) and fatigue strength (Fig 17) there is evidence of slightly more splitting in the case of XAS/914 even though there was no significant difference in strength. Fig 28 shows ONERA specimens which indicate that fatigue specimens suffer more splitting parallel to the fibres than specimens failed statically in tension. This is also shown for compression specimens, Fig 29. The fracture surfaces found by DFVLR after fatigue testing show that non-impacted specimens had relatively smooth fracture surfaces with much evidence of compression failures (Fig 30) while the impacted specimens showed more splitting and delamination (Fig 31).

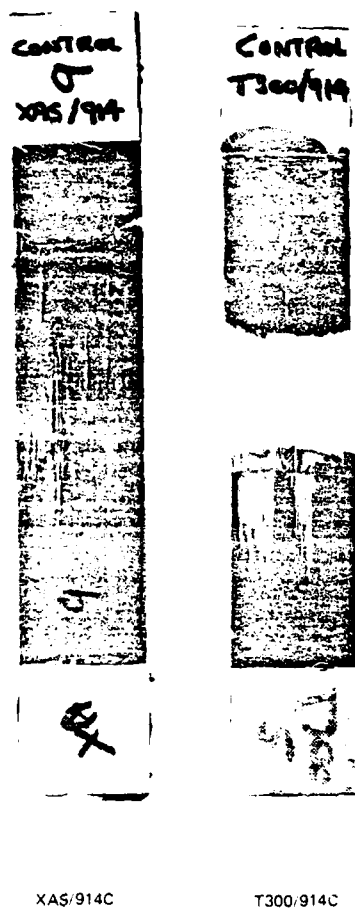
Fig 27 Static tensile failures in $[0\ 90\ 0\ \pm 45\ 0]_s$ carbon fibre laminates (RAE)
